May 24, 2017

Roofing Material Inspection and Observation Summary  
Additional Roof Repair/Overlay Work  
Hinsdale Middle School  
100 South Garfield Avenue  
Hinsdale, Illinois  
IES No. 915-17

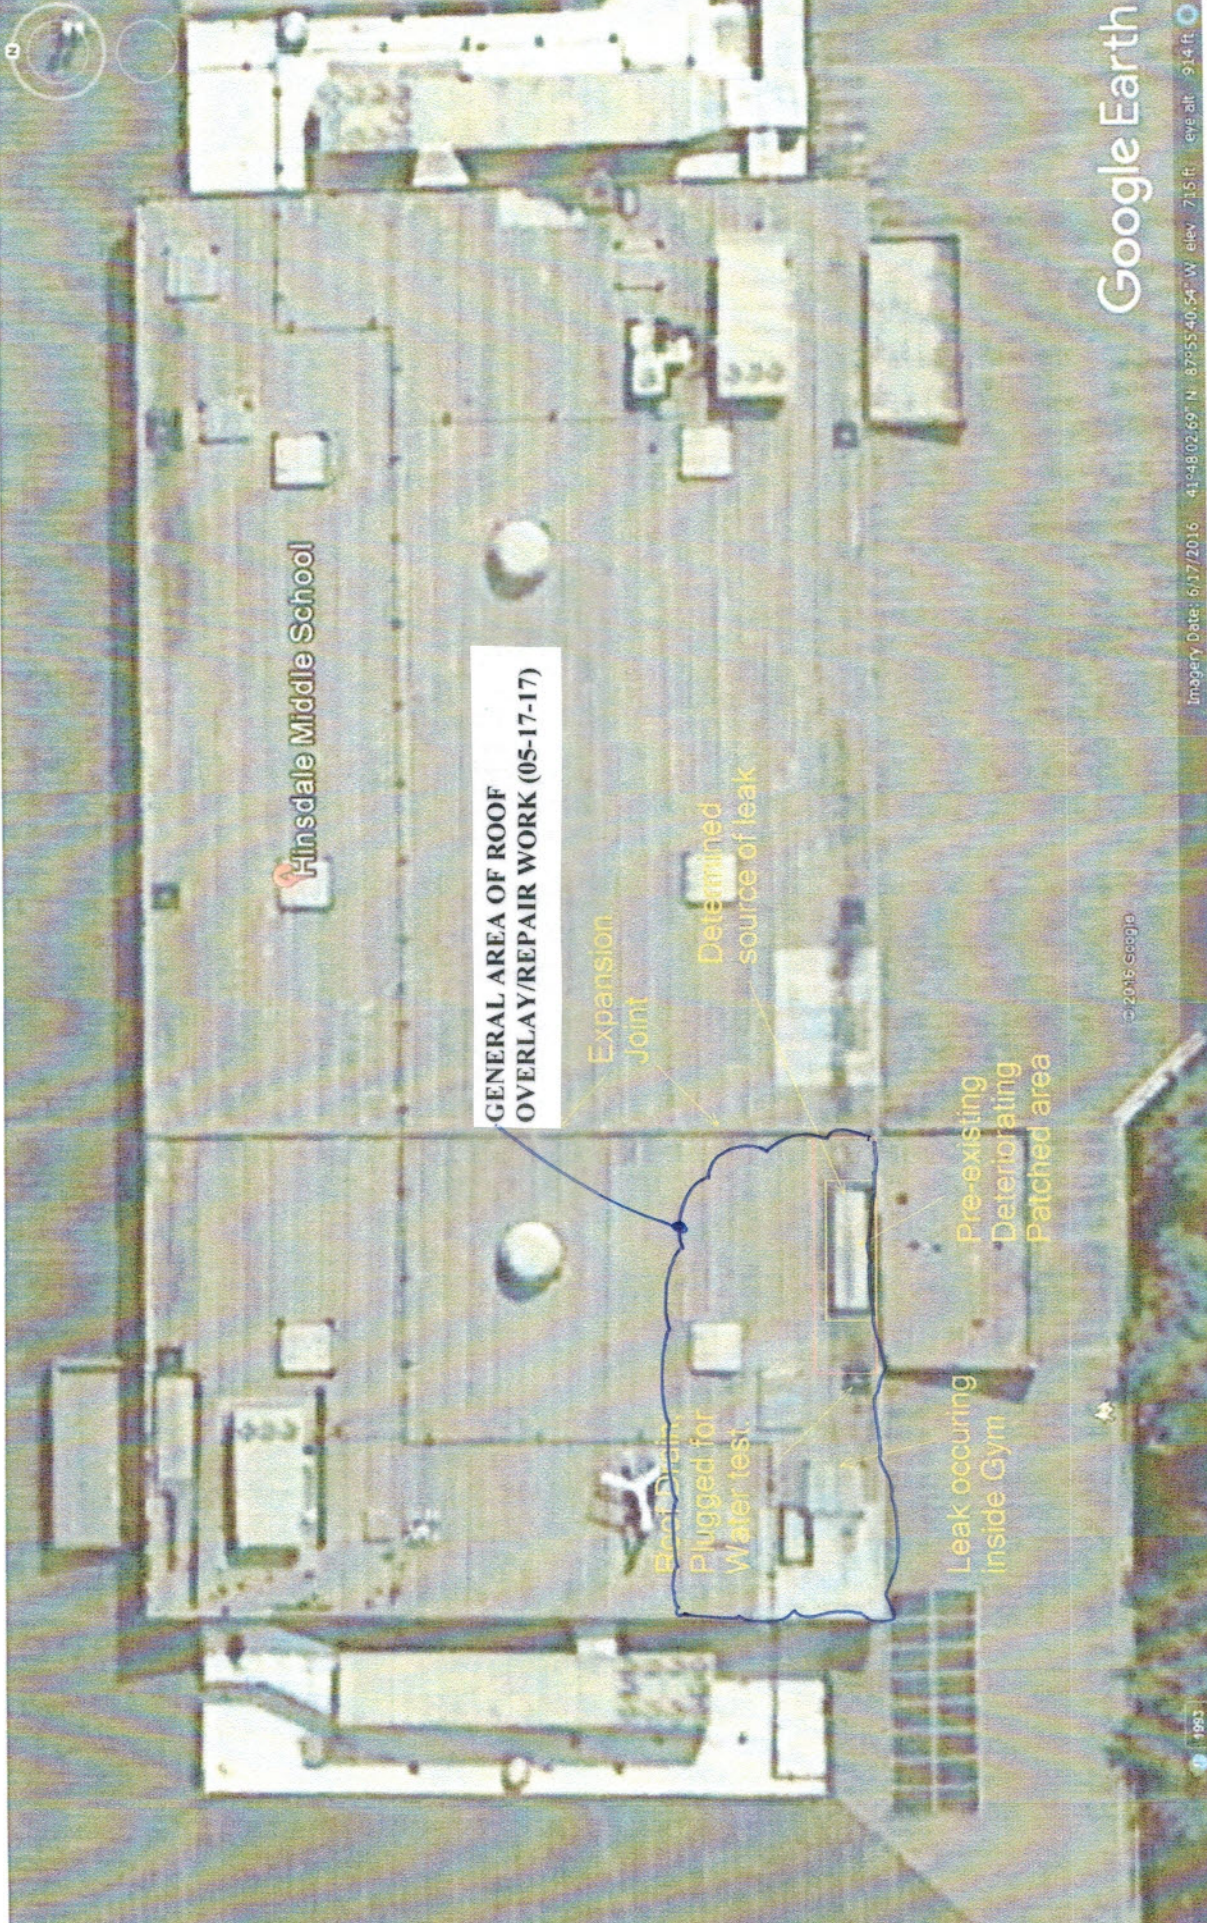
GENERAL AREA OF ROOF OVERLAY/REPAIR WORK (05-17-17)

Determined source of leak

Elect Drain  
Plugged for Water test

Leak occurring inside Gym

Pre-existing Deteriorating Patched area
