INDOOR AIR QUALITY ASSESSMENT REPORT

**COMMUNITY CONSOLIDATED SCHOOL DISTRICT 181
HINSDALE MIDDLE SCHOOL
100 SOUTH GARFIELD AVENUE
HINSDALE, ILLINOIS
IES NO. 915-01**

January 10, 2014

Final Report
Focused Indoor Air Quality Assessment
Community Consolidated School District 181
Hinsdale Middle School
100 South Garfield Avenue
Hinsdale, Illinois
IES No. 915-01

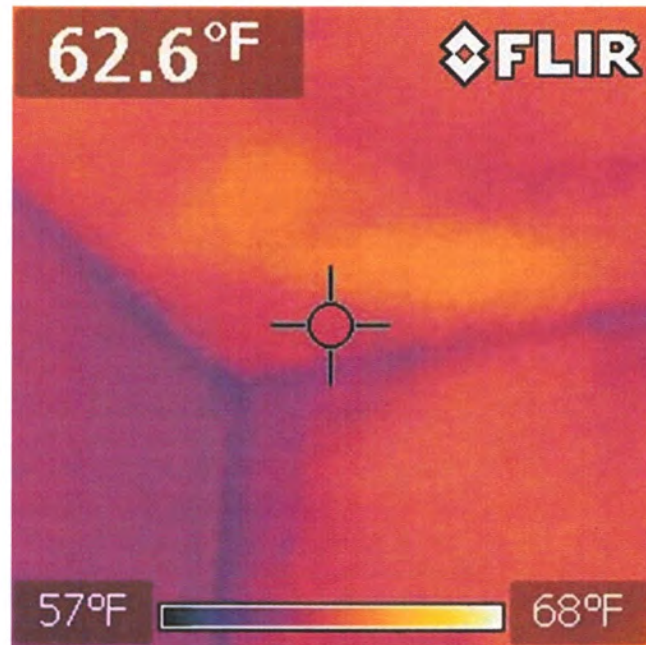
Scan Number: 9

Scan of wall/ceiling
intersection on south
wall above entrance to
stairwell S5.

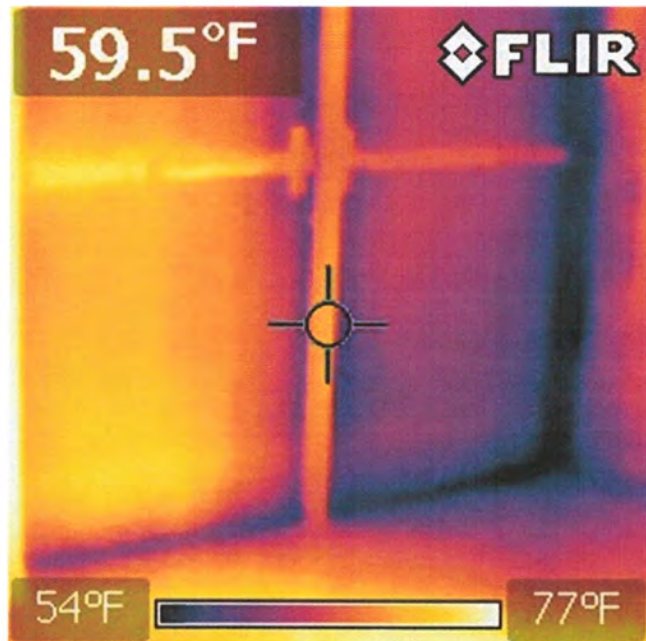
Scan Number: 10

Scan of exterior
doorway adjacent to
stairwell S5.

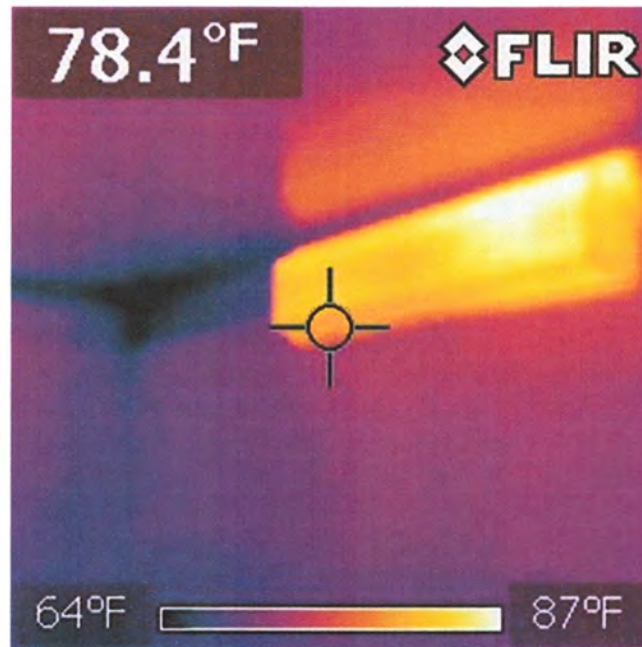
Scan Number: 11

Scan of wall/ceiling
intersection in southwest
corner of stairwell S5,
opposite stairwell S4.

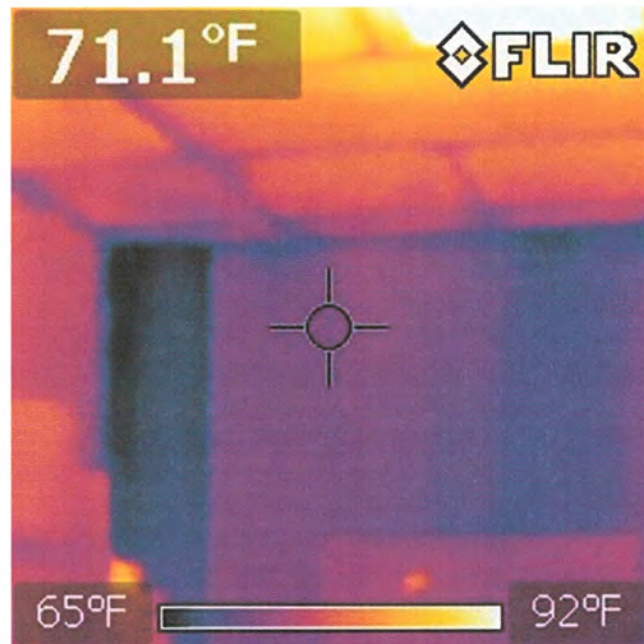
Scan Number: 13

Scan of south wall in
room 103C (Student
Services), opposite
stairwell S5.

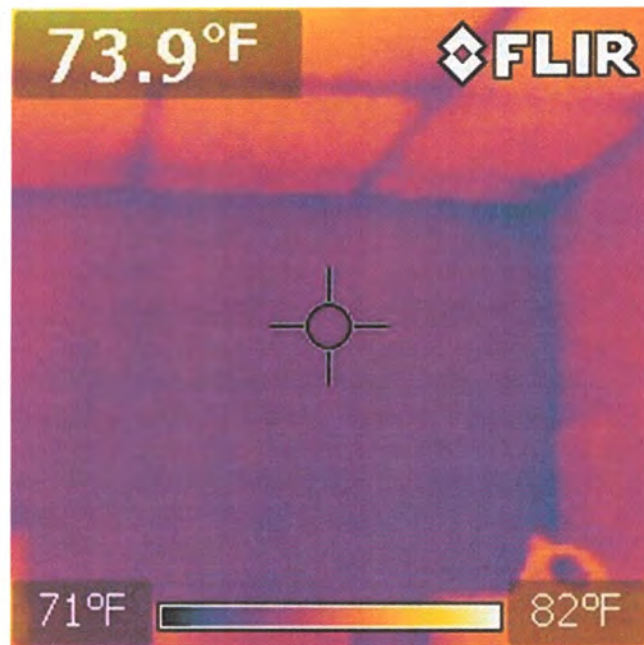
Scan Number: 14

Scan of south wall in
room 136 (Student
Services), opposite
stairwell S5.

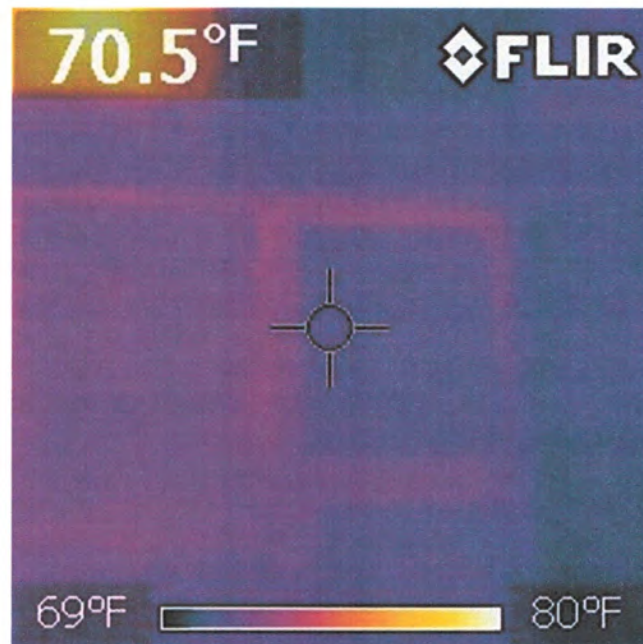
Scan Number: 15

Scan of west wall in
classroom 124 (music).

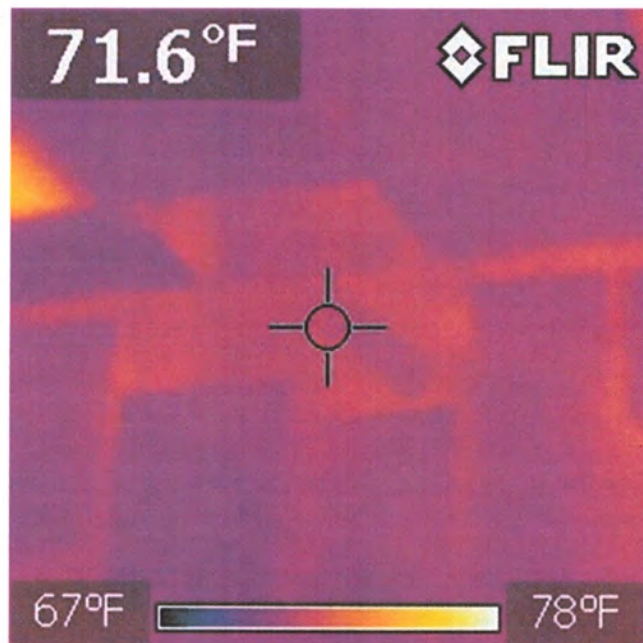
Scan Number: 16

Scan of west wall in
classroom 124 (music).

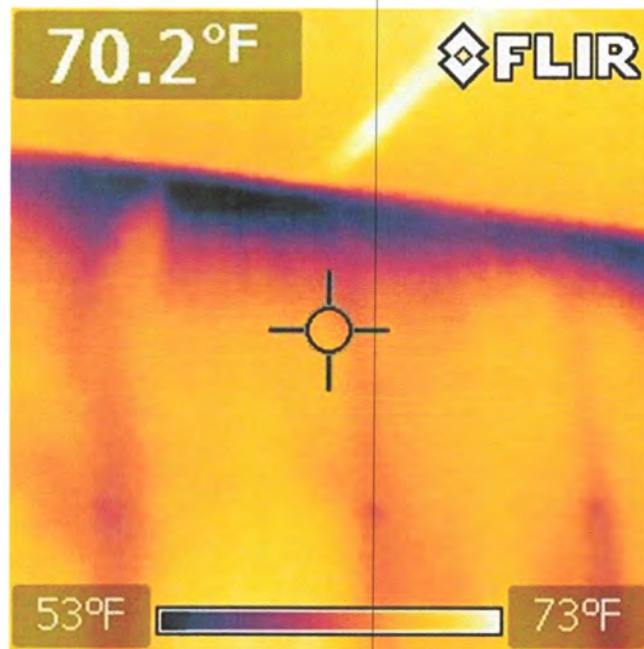
Scan Number: 21

Scan of east portion of
south wall in classroom
222.

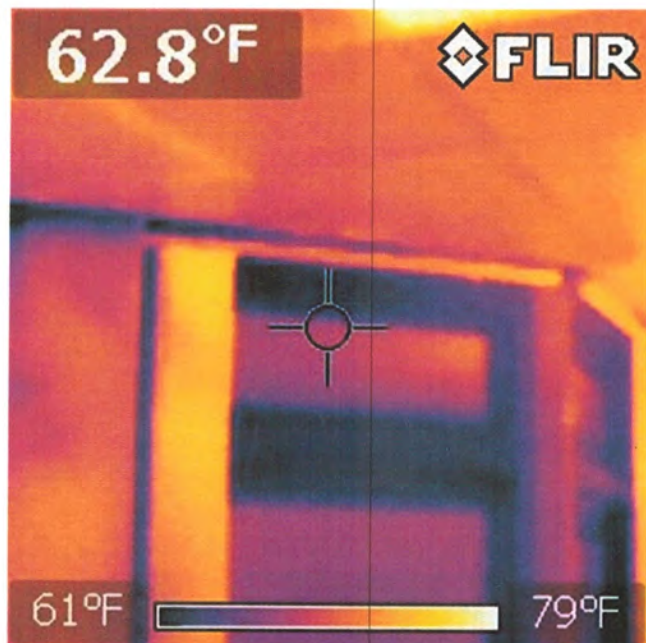
Scan Number: 22

Scan of south wall and
balcony door in
classroom 222.

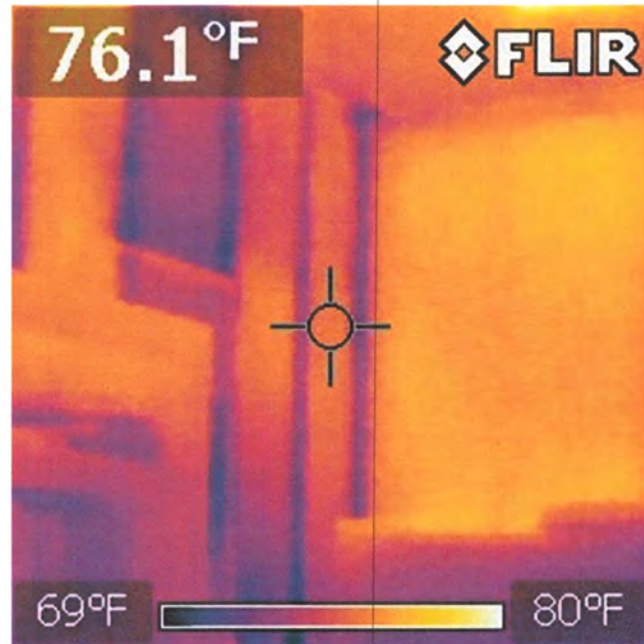
Scan Number: 23

Scan of southwest
corner in classroom 222.

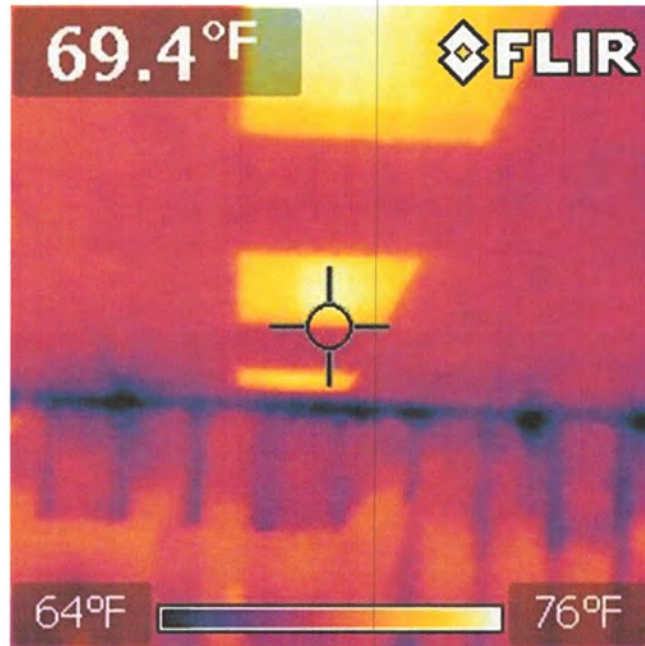
Scan Number: 25

Scan of ceiling/wall
intersection along south
wall in classroom 225.

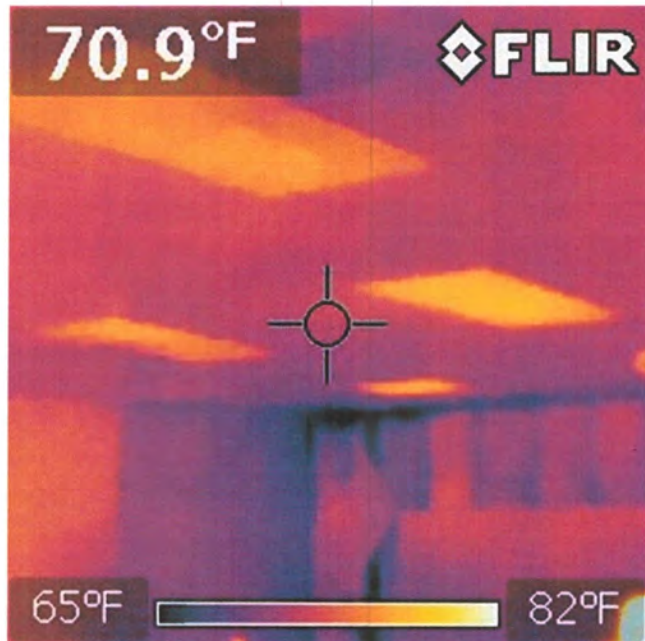
Scan Number: 26

Scan of ceiling/wall
intersection in southeast
corner of classroom 225.

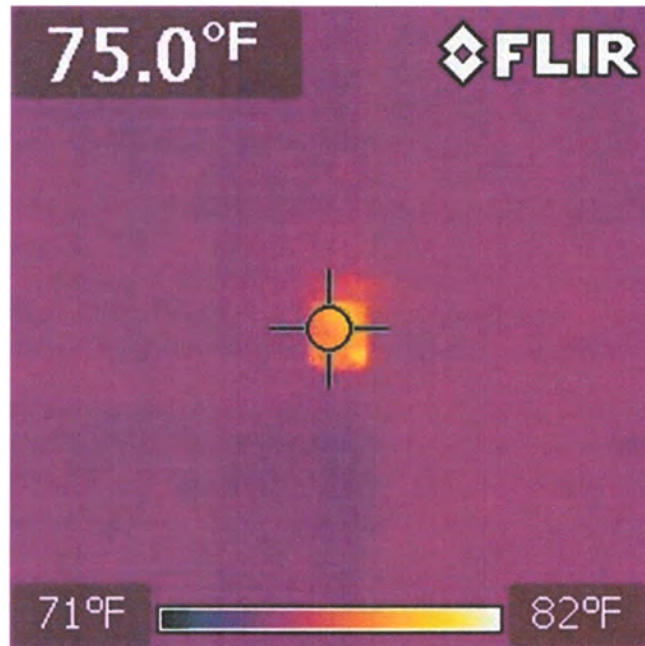
Scan Number: 27

Scan northeast corner of
room R230 (boys'
restroom).

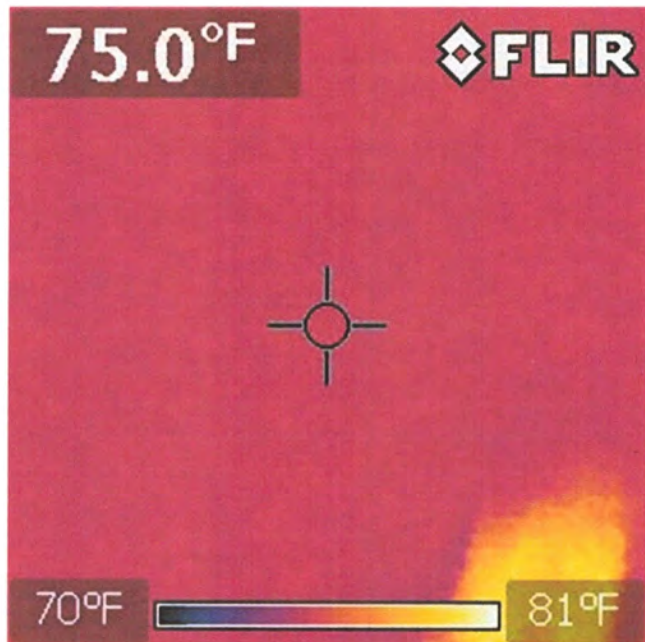
Scan Number: 28

Scan of southeast corner
of room R230 (boys'
restroom).

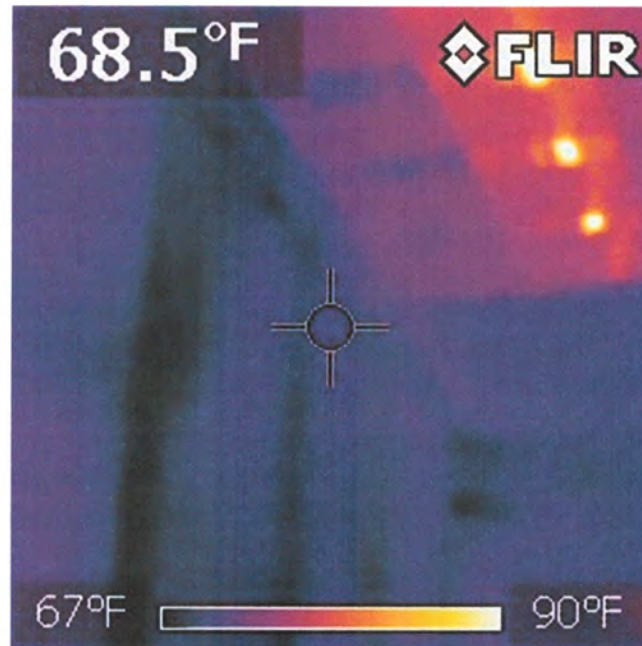
Scan Number: 29

Scan of east wall in
classroom 228, adjacent
to classroom entry door.

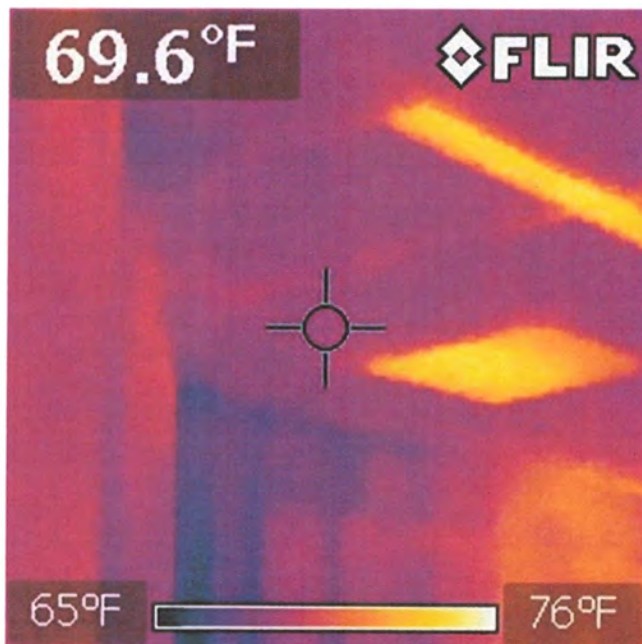
Scan Number: 30

Scan of ceiling in
southeast corner of
classroom 228.

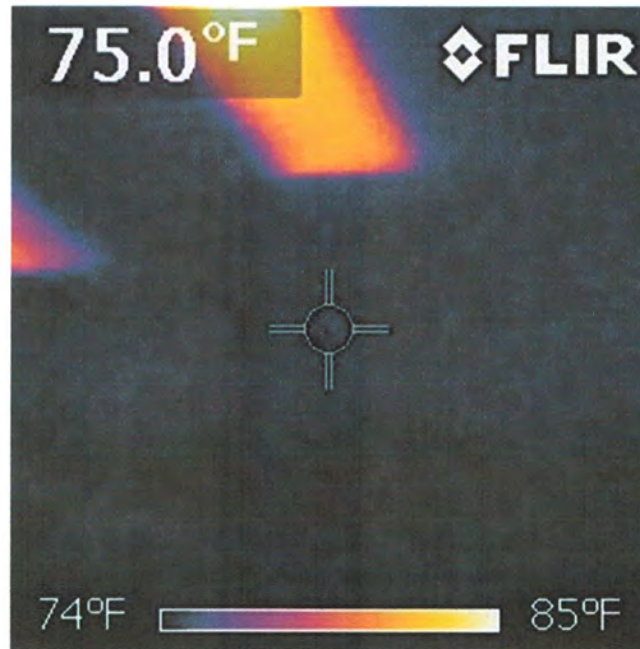
Scan Number: 31

Scan of east and south
walls in room R231
(girls' restroom).
