INDOOR AIR QUALITY ASSESSMENT REPORT
EARLY JANUARY 2015 WATER INTRUSION EVENT

COMMUNITY CONSOLIDATED SCHOOL DISTRICT 181
HINSDALE MIDDLE SCHOOL
100 SOUTH GARFIELD AVENUE
HINSDALE, ILLINOIS
IES NO. 915-08

January 14, 2015

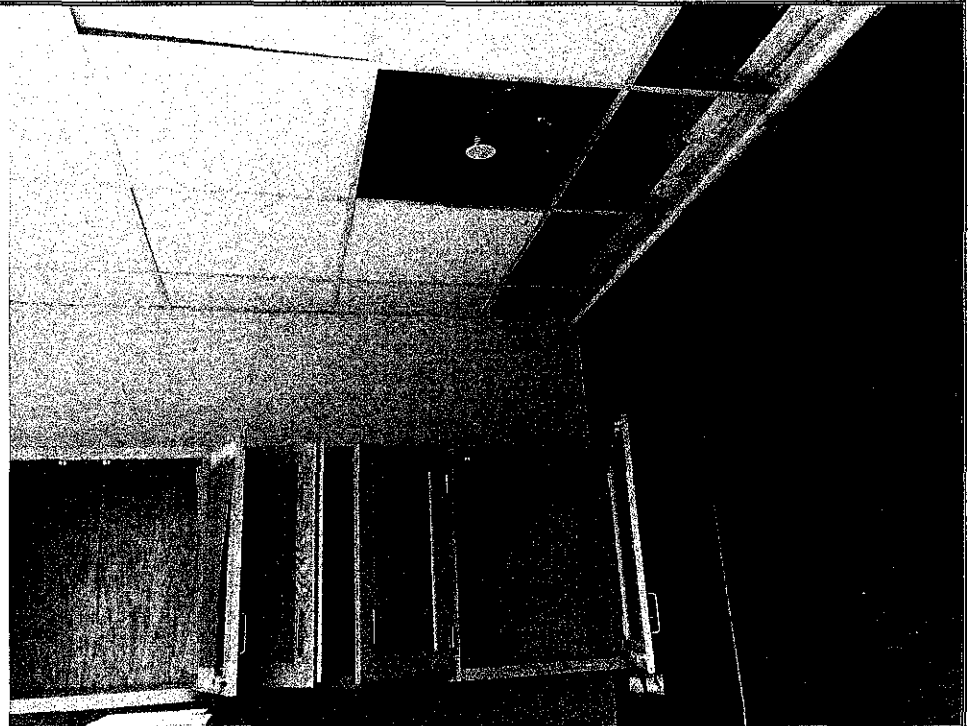
Photo Number: 1

View of sprinkler pipe
above Classroom 215
that froze and burst on
the evening of
01/08/15, causing a
water intrusion event.

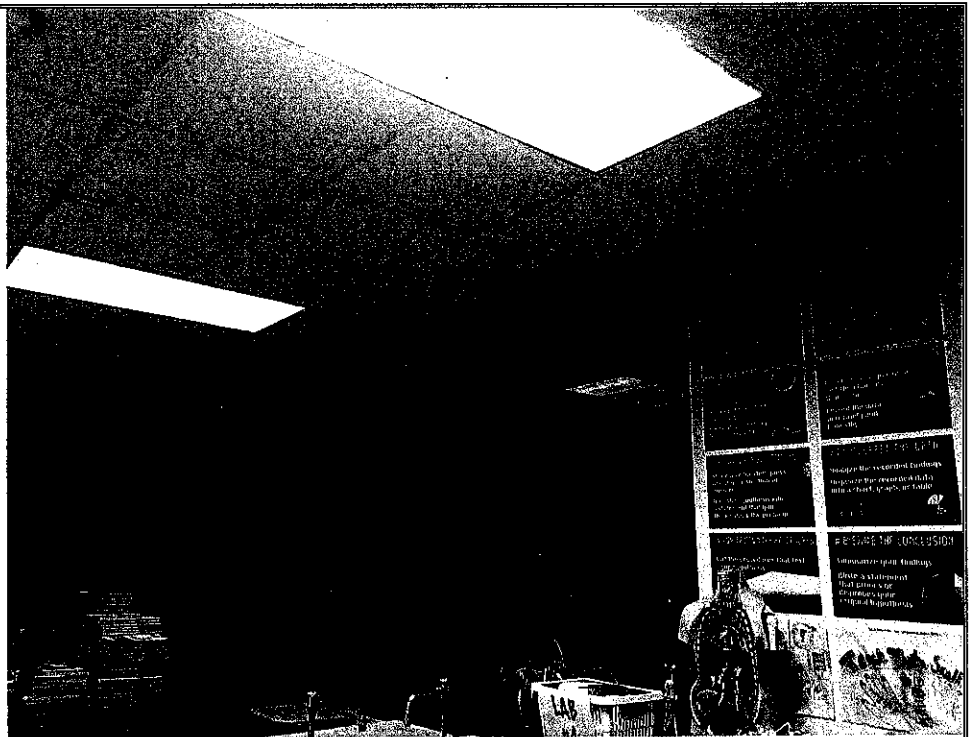
Photo Number: 2

Additional view of
sprinkler pipe area
above ceiling in
Classroom 215 that
froze and burst on the
evening of 01/08/15
causing a water
intrusion event. Also
viewed are missing
water impacted ceiling
tiles

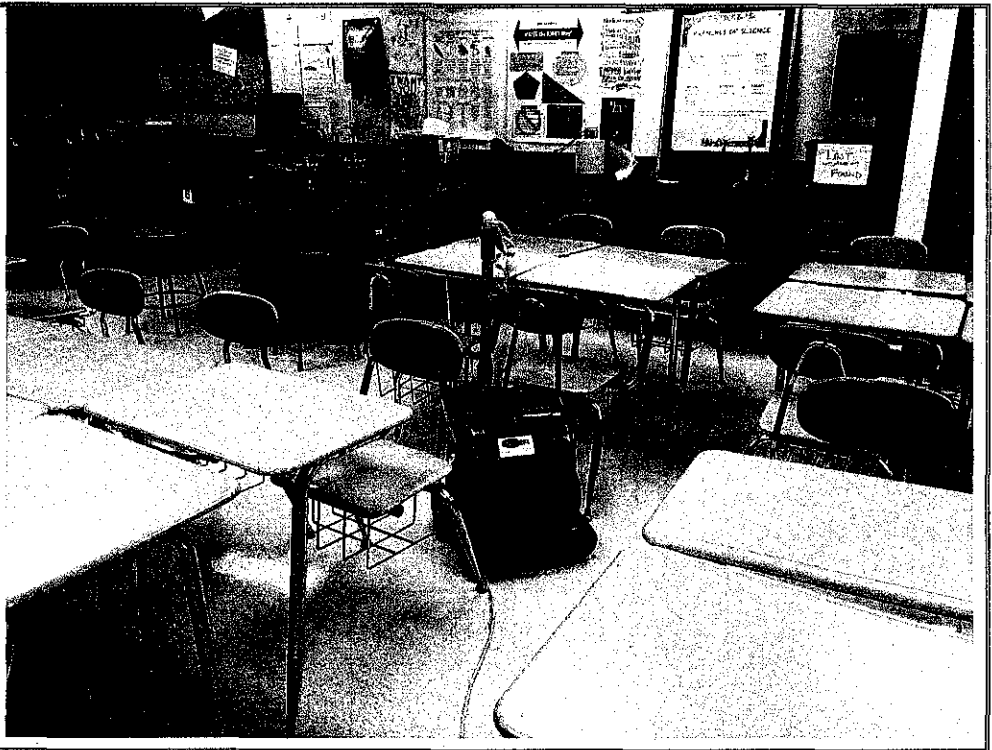
Photo Number: 3

View of fan used within
Classroom 215 to
circulate air in order to
dry surfaces and
evaporate any remaining
water.

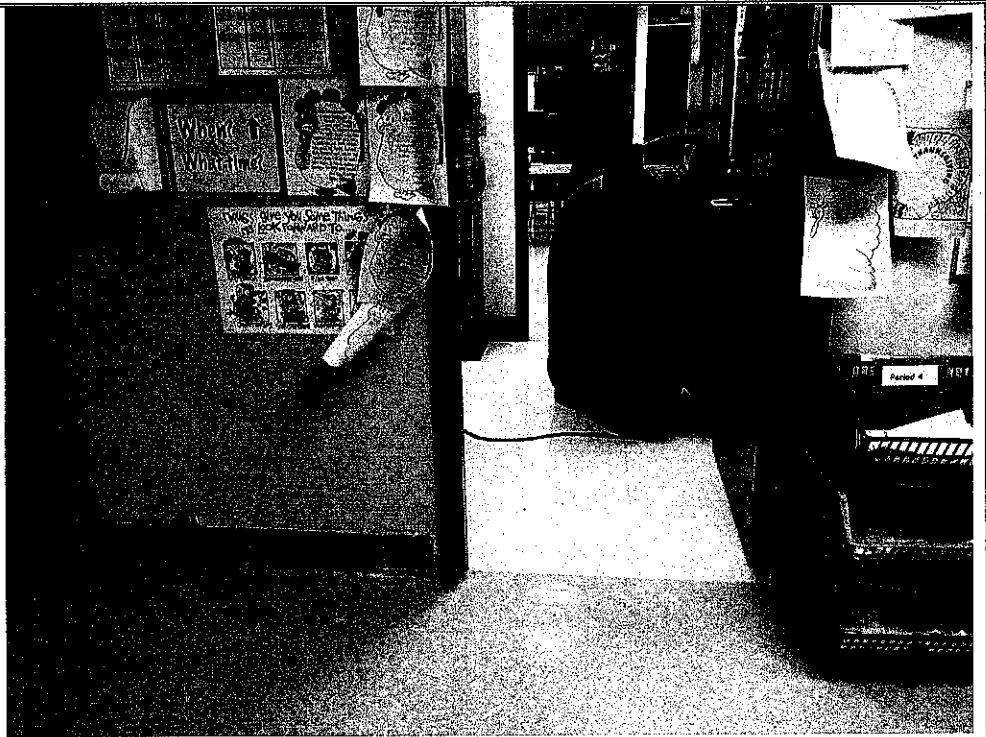
Photo Number: 4

View of dehumidifier placed in prep room between Classrooms 215 and 216 following clean-up and water extraction within Classroom 215. Also viewed is a portion of drywall removed following water damage.

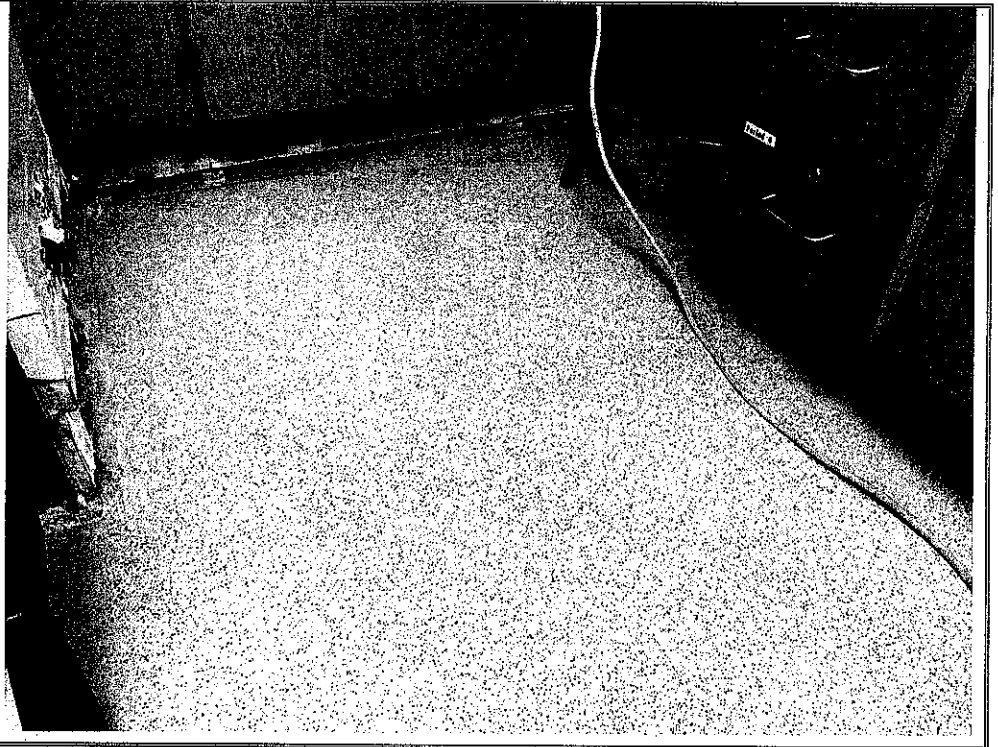
Photo Number: 5

View of baseboards
removed from
Classroom 215 to aid in
water removal and air
circulation/drying within
classroom.

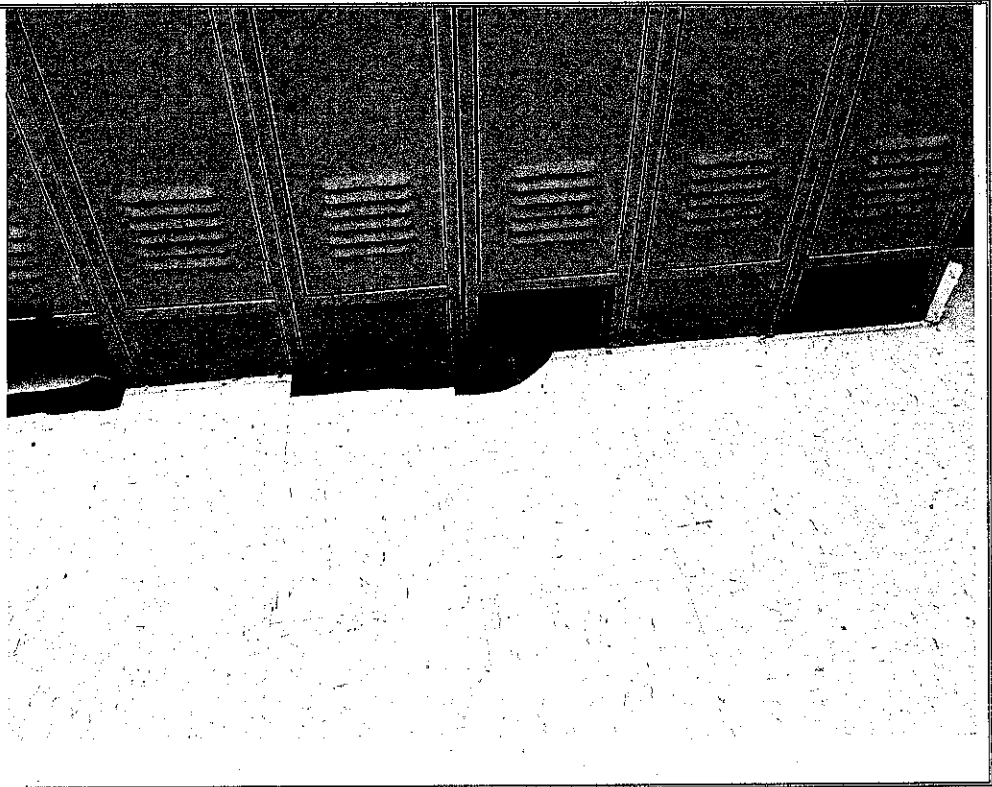
Photo Number: 6

View of baseboards removed from base of lockers in hallway adjacent to Classroom 215 to aid with water extraction and drying. Also viewed are Non-ACM floor tiles damaged during baseboard removal.

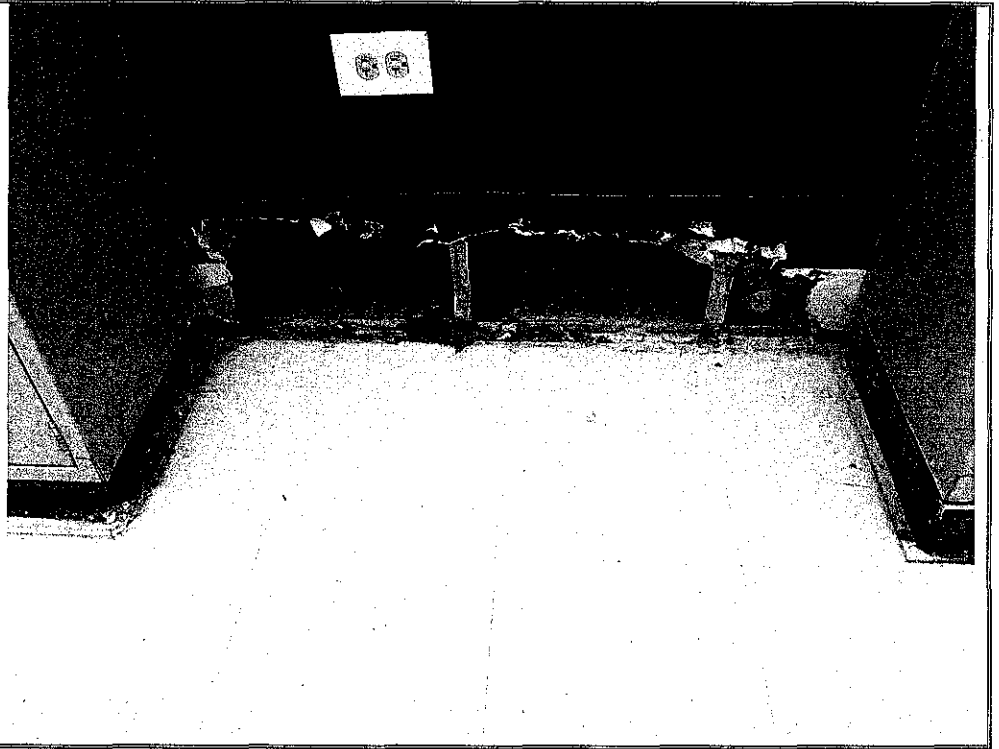
Photo Number: 7

View of base and water-impacted drywall removed to help facilitate further drying within wall in hallway following 01/08/15 water intrusion event within Classroom 215.

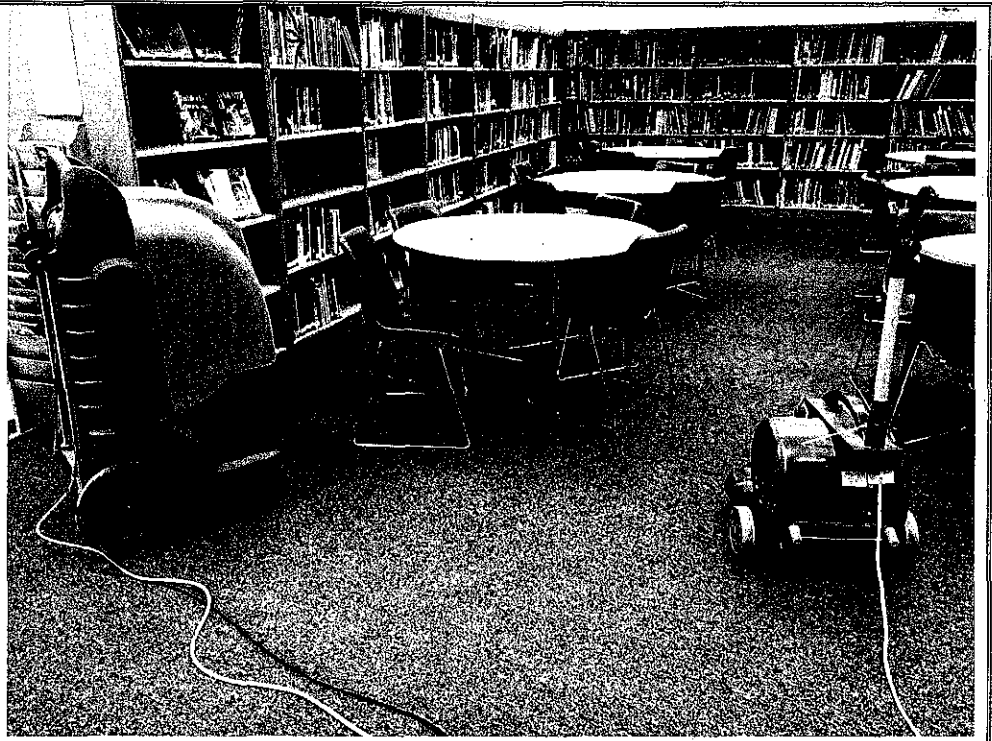
Photo Number: 8

View of fan unit and
dehumidifier being used
within the MRC to dry
water impacted
carpeting following
water intrusion event
within adjacent
Classroom 215.

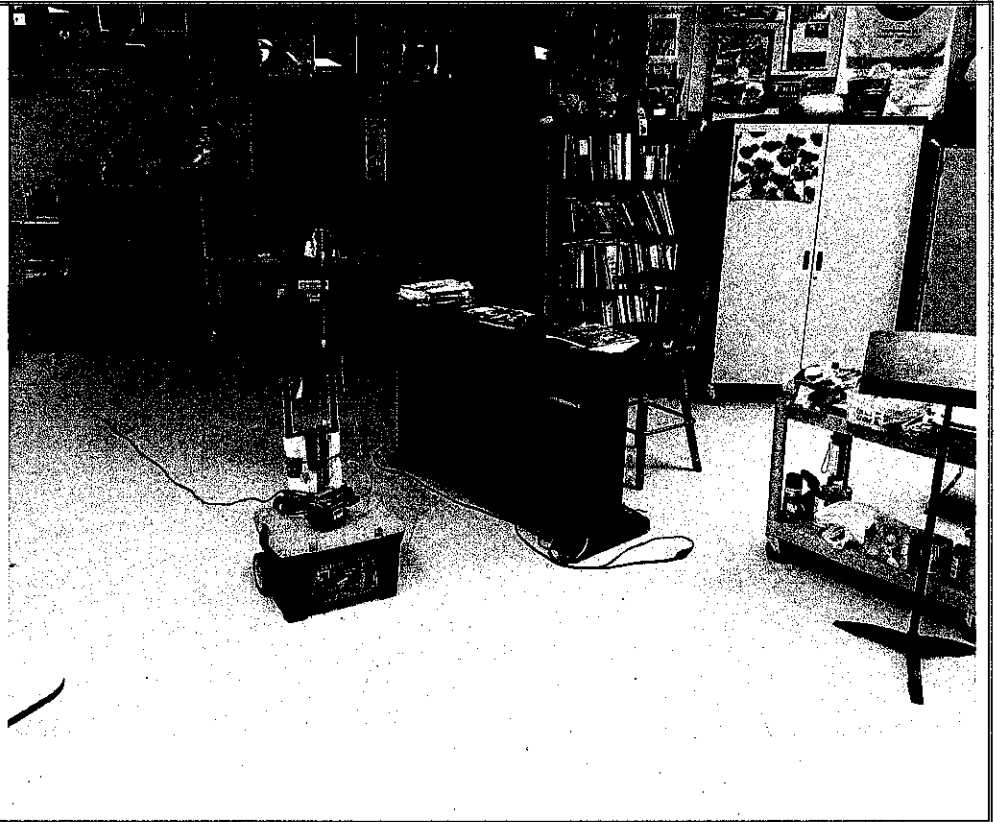
Photo Number: 10

Representative view of
air sample for mold
spores being collected
within Classroom 124.
Air samples were
collected from
Classroom 215 and
adjacent areas following
the clean-up of the
01/08/15 water intrusion
event.
