Commercial Radon Survey Report

Client: Community Consolidated School District 181
Site Address: Hinsdale Middle School
100 S Garfield
Hinsdale, IL 60521
Survey Date: May 21, 2012 to May 23, 2012

Follow-Up Testing

RDS-R-002
Prepared by: Kirsten Schmidt
IL Professional Radon License RNI2006204
Licensed for Residential and Commercial Radon Testing

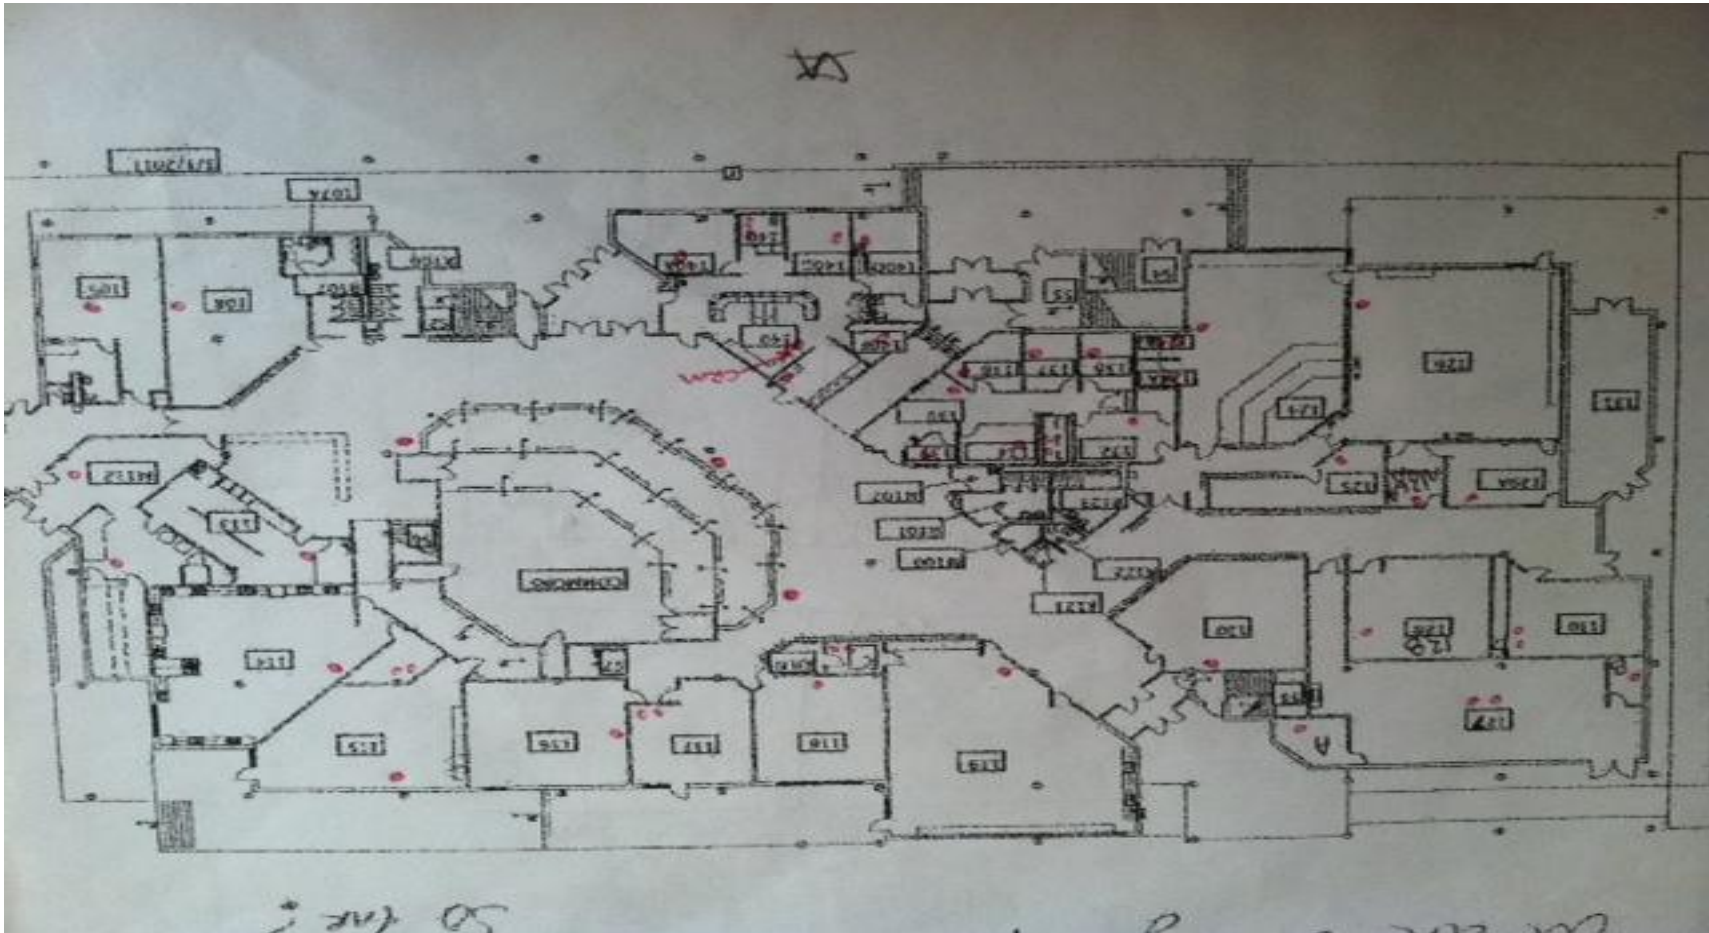
Appendix A: Site Plan Showing Device Locations

The radon levels were BELOW the recommended action level in Room 126A. Air exchange rates for the facility were not available at the time of testing. Air exchange rates can affect the radon concentration based on dilution of radon gas.
