INDOOR AIR QUALITY ASSESSMENT REPORT

**COMMUNITY CONSOLIDATED SCHOOL DISTRICT 181
HINSDALE MIDDLE SCHOOL
100 SOUTH GARFIELD AVENUE
HINSDALE, ILLINOIS
IES NO. 915-01**

January 10, 2014

Final Report
Focused Indoor Air Quality Assessment
Community Consolidated School District 181
Hinsdale Middle School
100 South Garfield Avenue
Hinsdale, Illinois
IES No. 915-01

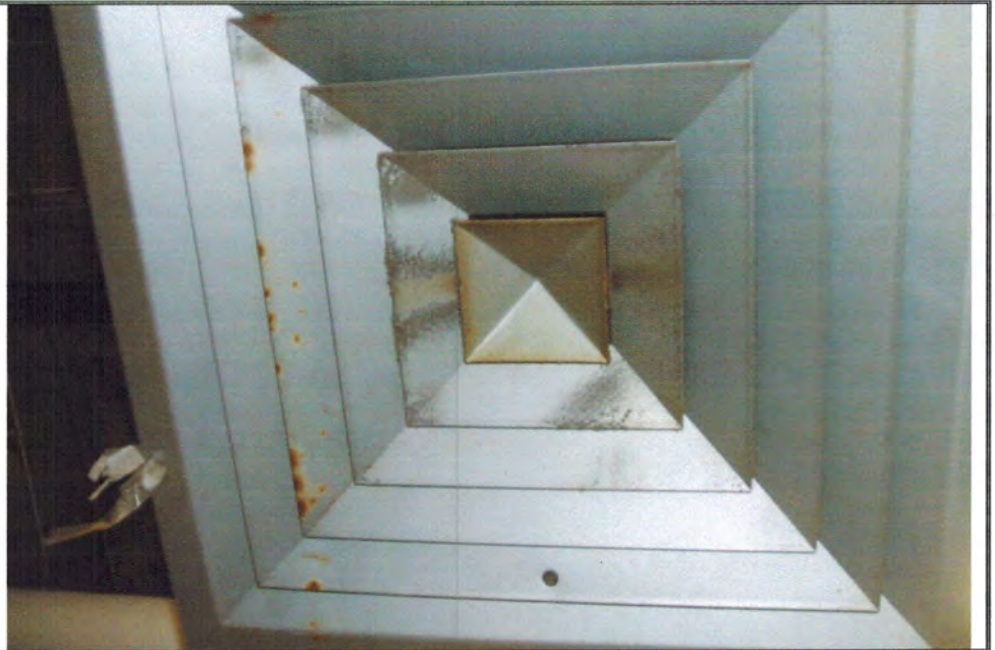
Photo Number: 1

View of dust on supply
vent diffuser in Room
M112 (Maintenance
Area).

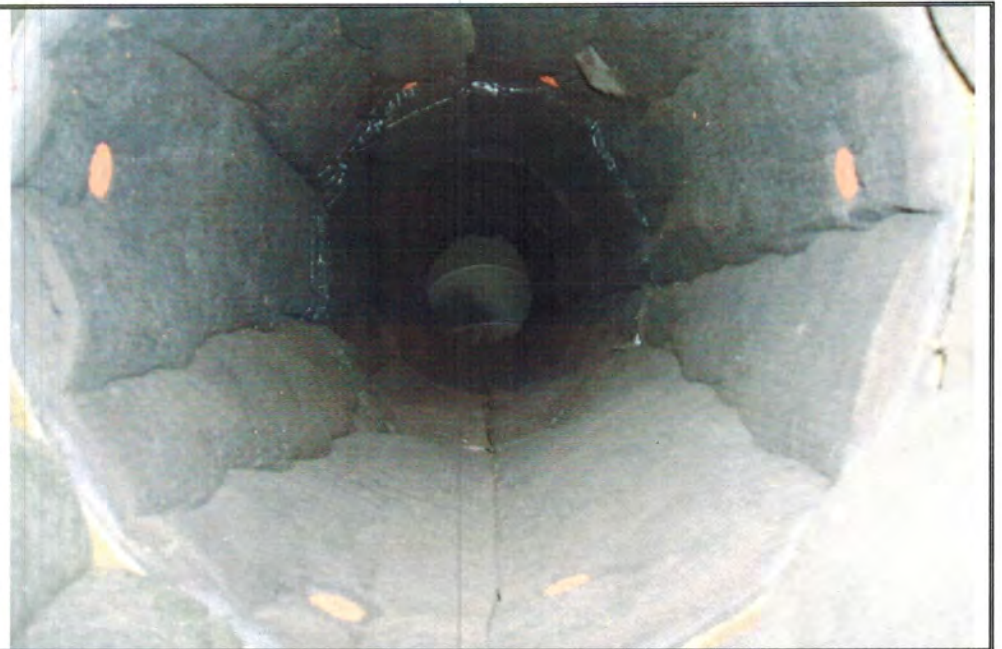
Photo Number: 4

Additional view of HVAC duct interior in commons area. Note that duct is not continually lined.

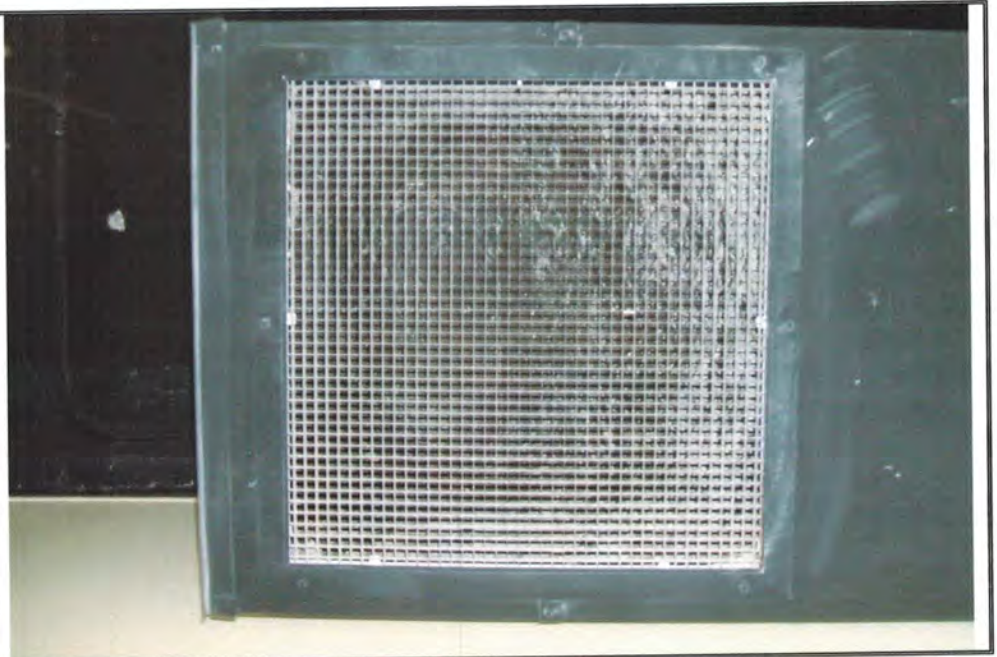
Photo Number: 5

View of return air vent cover in classroom 119.
Note presence of large amount of dust build-up on vent cover.

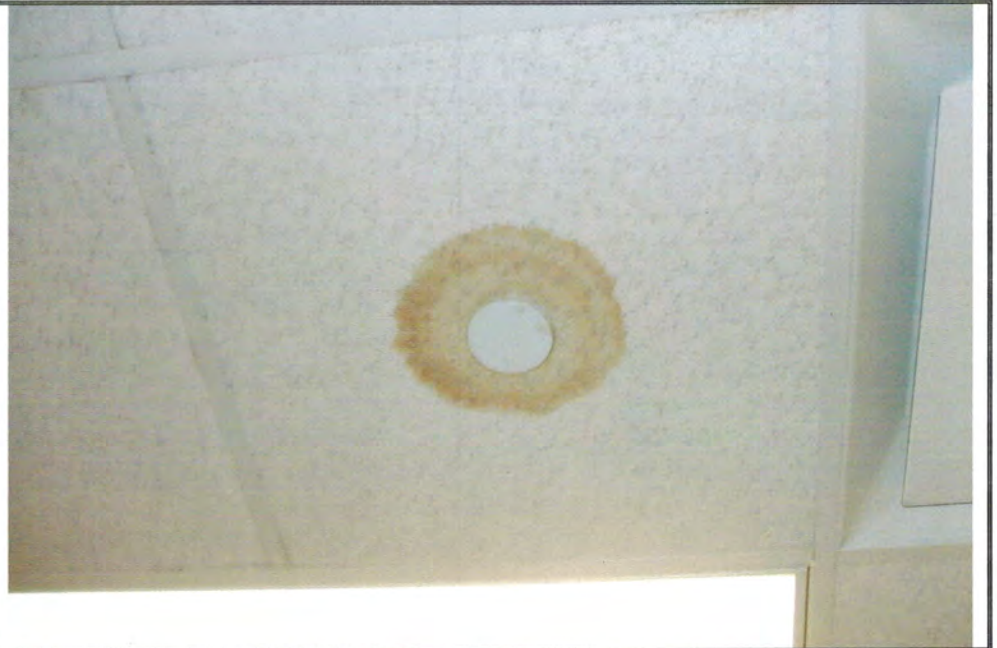
Photo Number: 7

View of recent water stain on ceiling tile in northeast corner of classroom 116. Water stain surrounds sprinkler head.

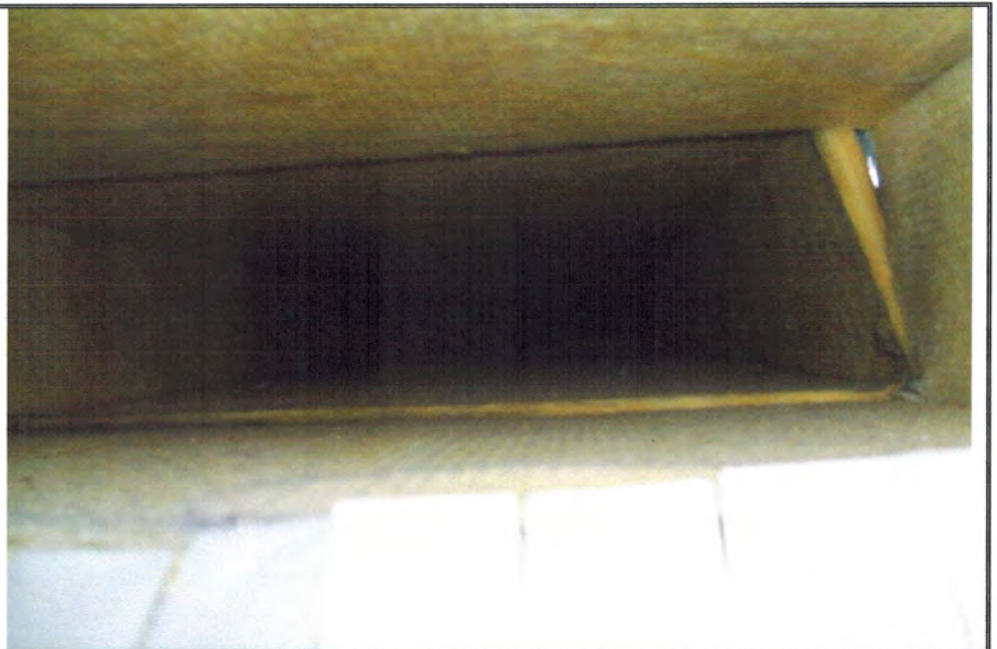
Photo Number: 8

View of fiberglass lined supply duct interior above ceiling in portable classroom 3. Note presence of small bits of debris within duct.

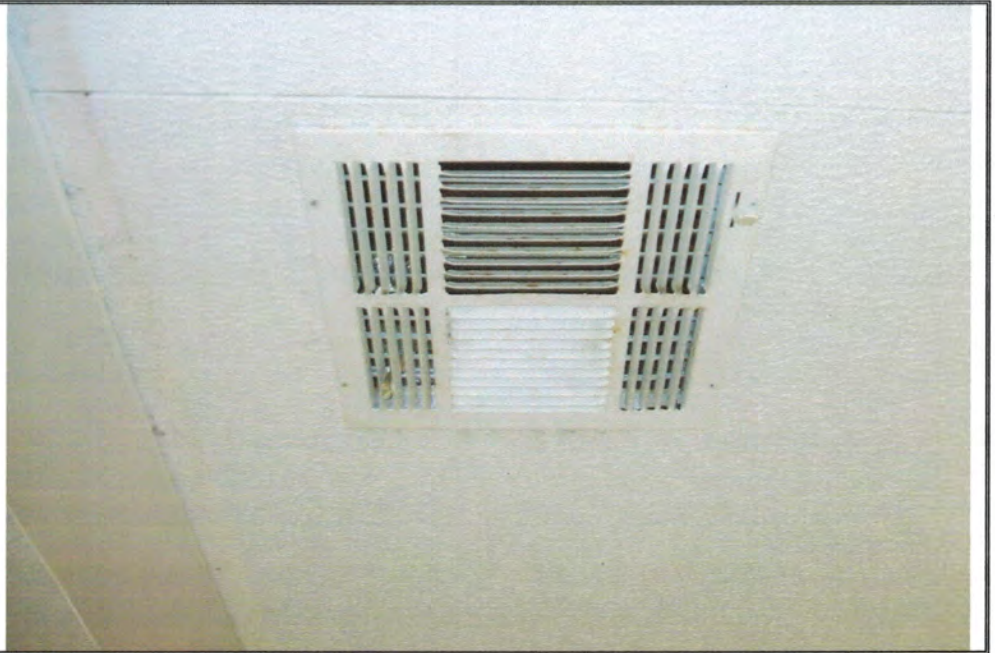
Photo Number: 9

View of supply vent
cover on ceiling of
portable classroom 1.

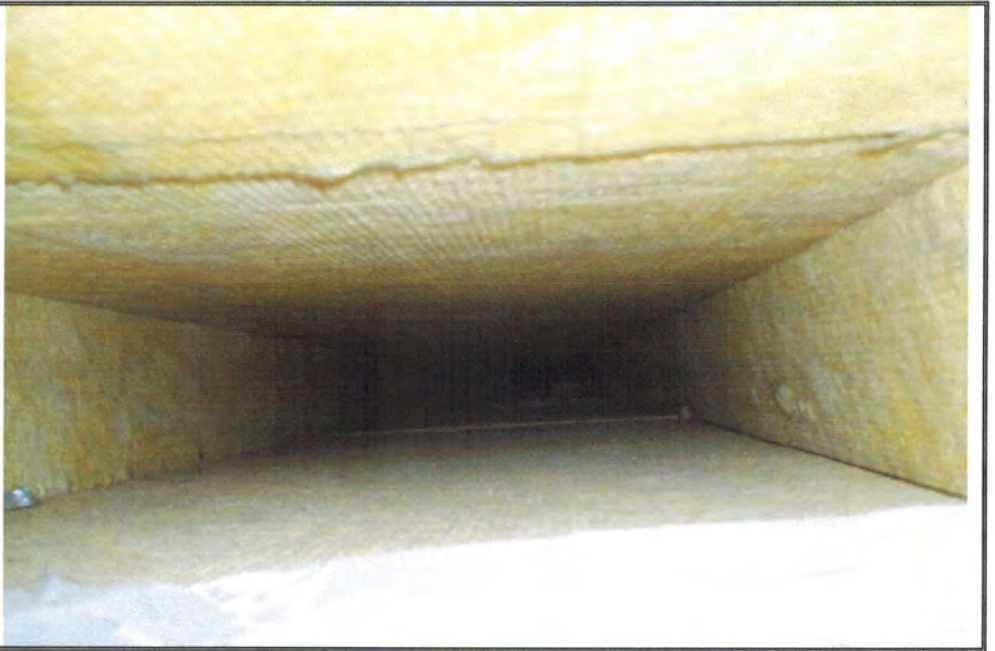
Photo Number: 10

View of fiberglass lined
supply duct interior
above ceiling in portable
classroom 1. Note
presence of small bits of
debris within duct.

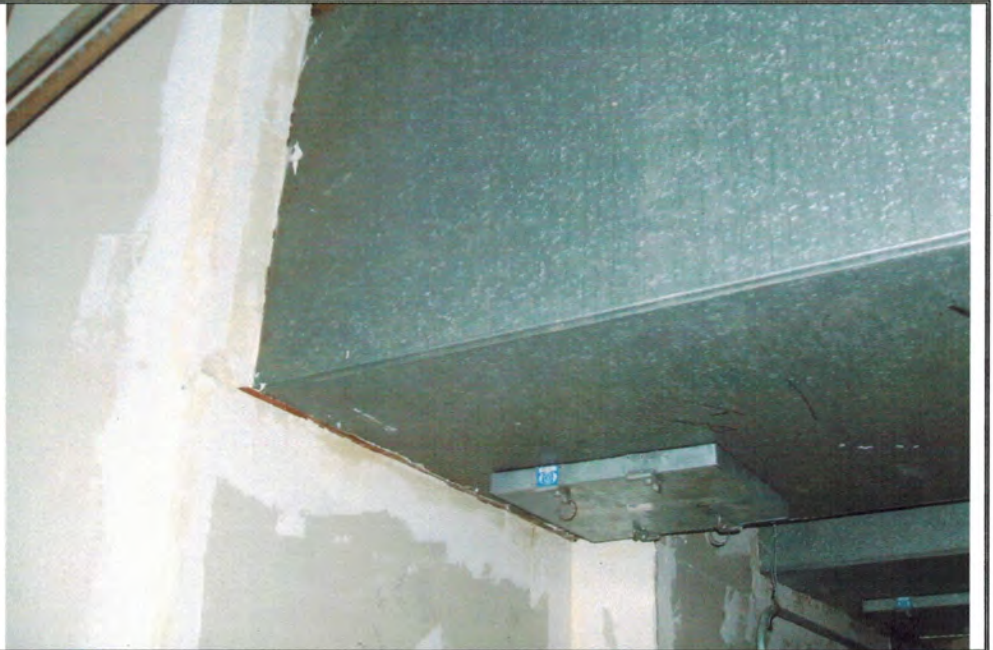
Photo Number: 11

View of supply duct
access hatch above
ceiling on south wall of
classroom 228.

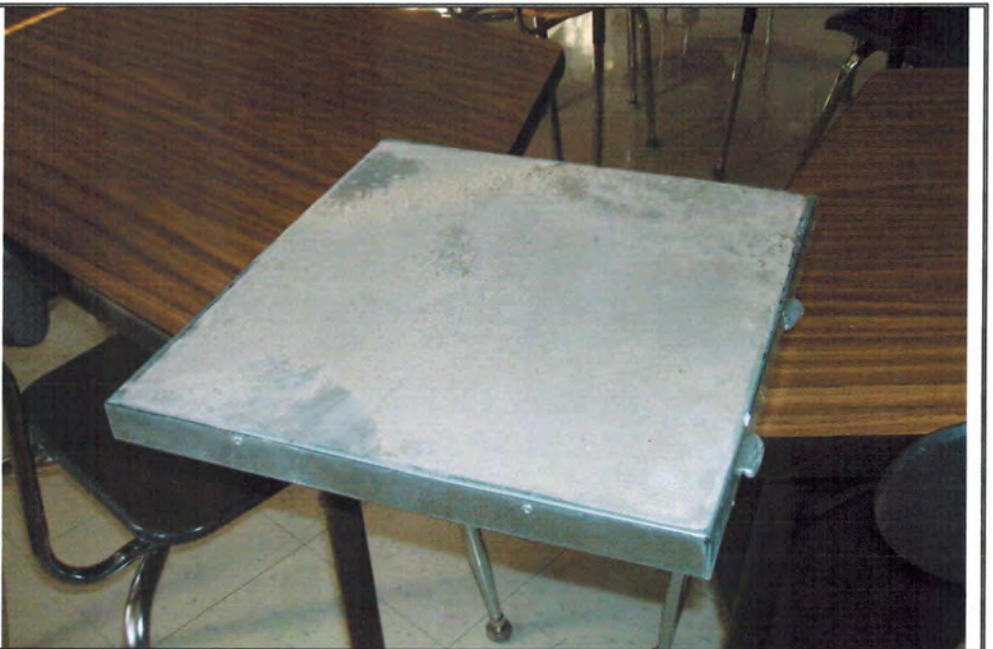
Photo Number: 12

View of dust-covered
interior surface of
supply duct access hatch
above ceiling on south
wall of classroom 228.

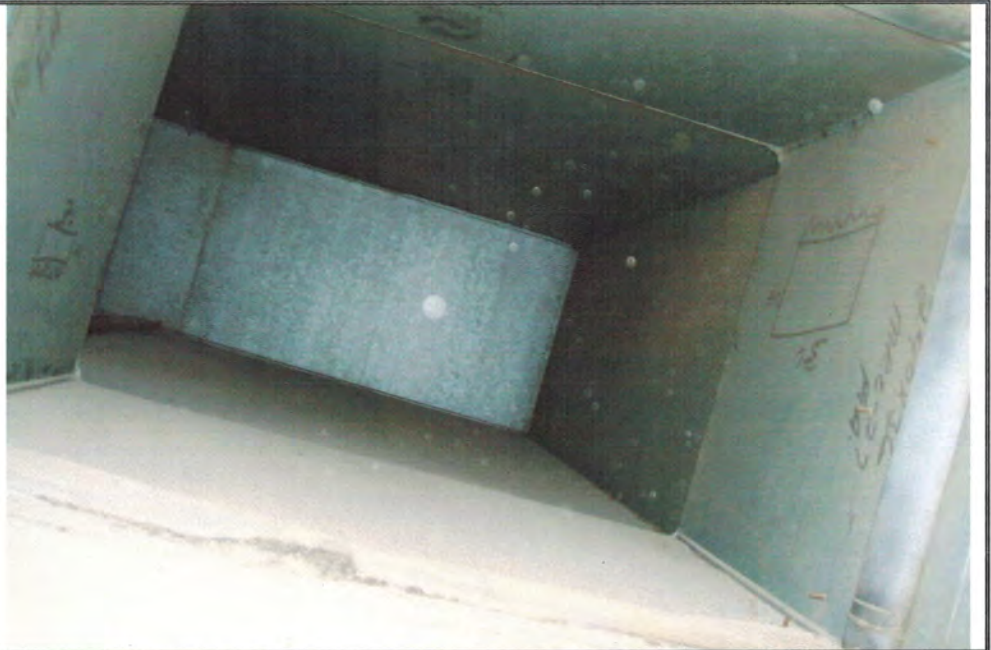
Photo Number: 13

View of dust-covered
interior surface of
supply duct above
ceiling on south wall of
classroom 228.

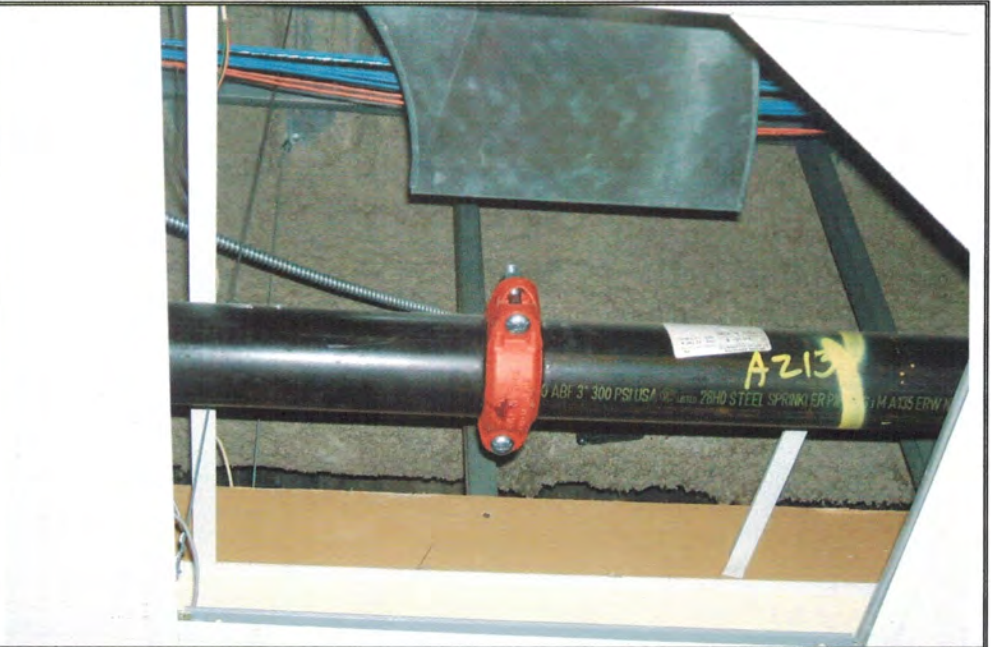
Photo Number: 14

View of open return
duct in close proximity
to spray-applied
fireproofing above
ceiling of MRC.

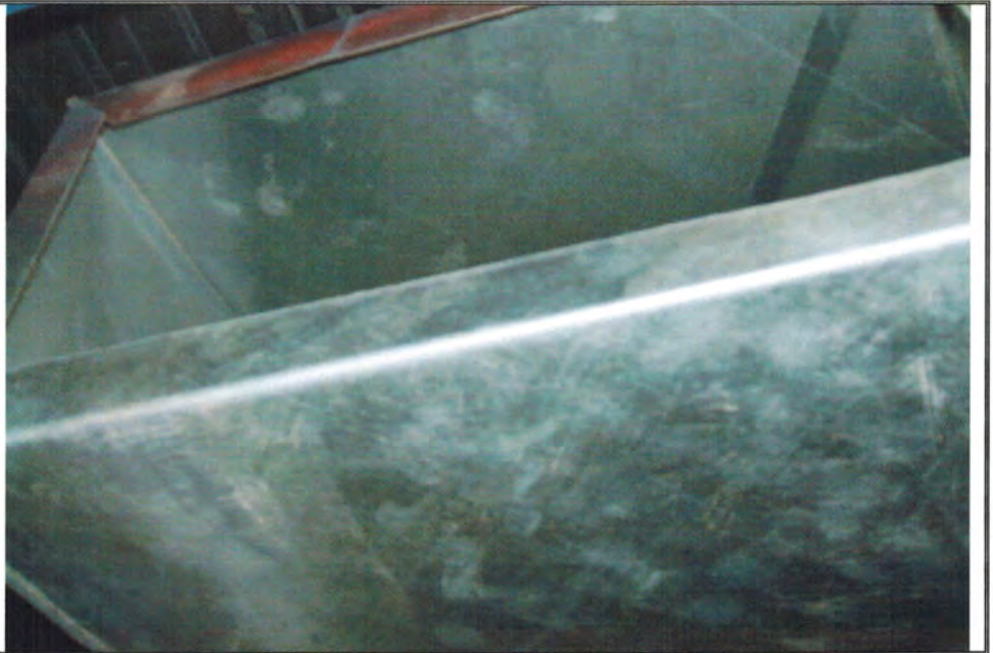
Photo Number: 15

Additional view of open
return duct in close
proximity to spray-
applied fireproofing
above ceiling of MRC.

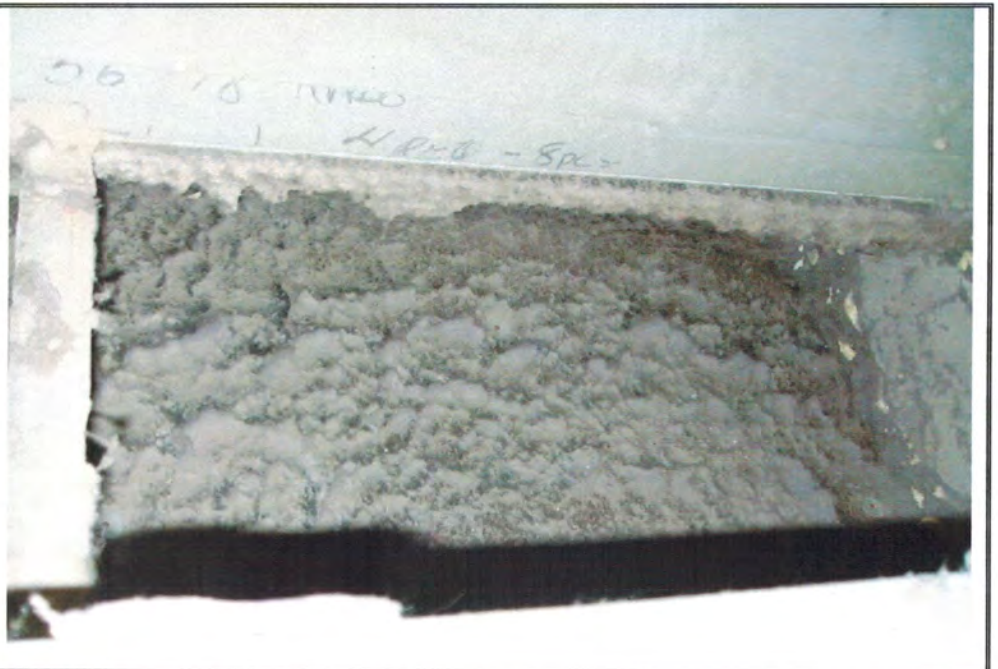
Photo Number: 16

View of fiberglass-lined
HVAC return duct on
northeast side of
gymnasium by P.E.
Office. Note how dusty
lining appears. (Photo
turned sideways)

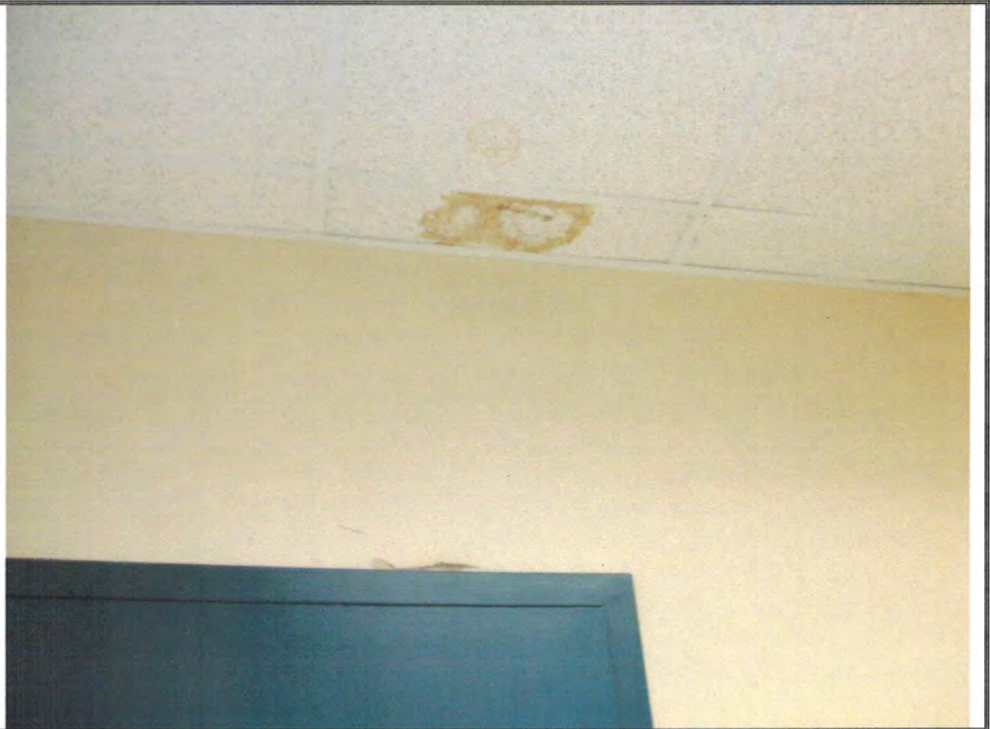
Photo Number: 17

View of water-stained
ceiling tile above
gymnasium door in
stairwell S1.

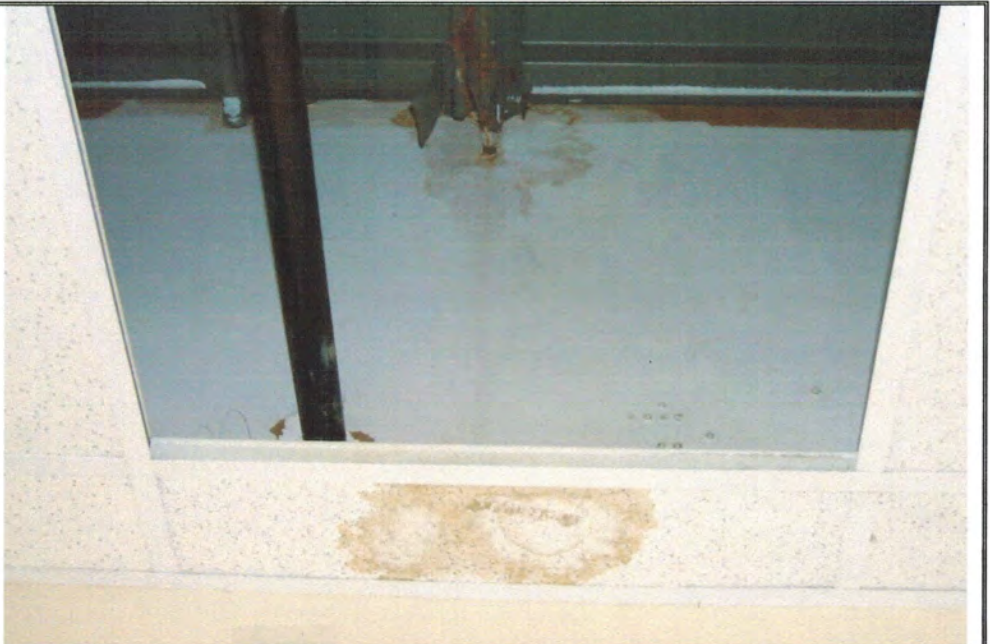
Photo Number: 18

View of water-stained
drywall above water-
stained ceiling tiles in
stairwell S1.

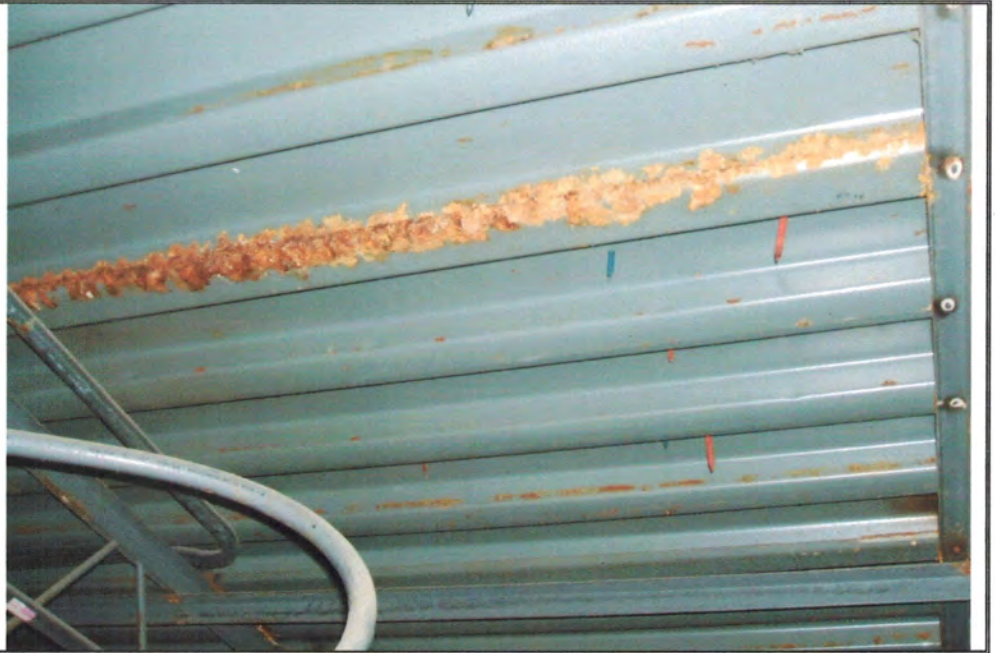
Photo Number: 19

View of rust on metal ceiling deck above lay-in ceiling in stairwell S1. Rust is indication of past water intrusion.

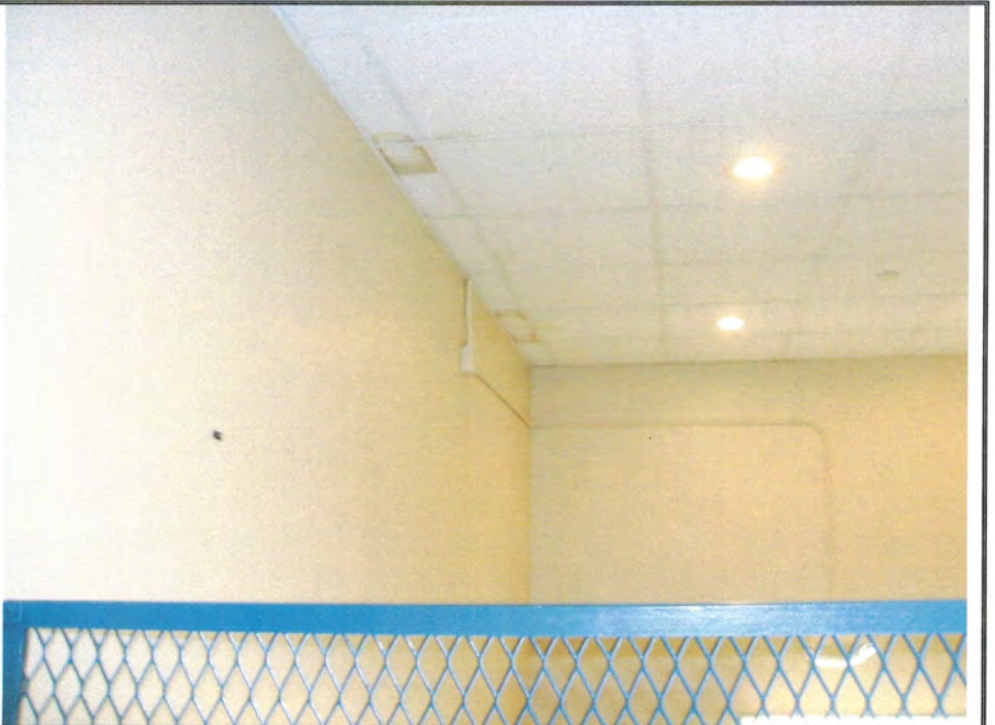
Photo Number: 20

View of additional water-stained ceiling tiles in stairwell S1.

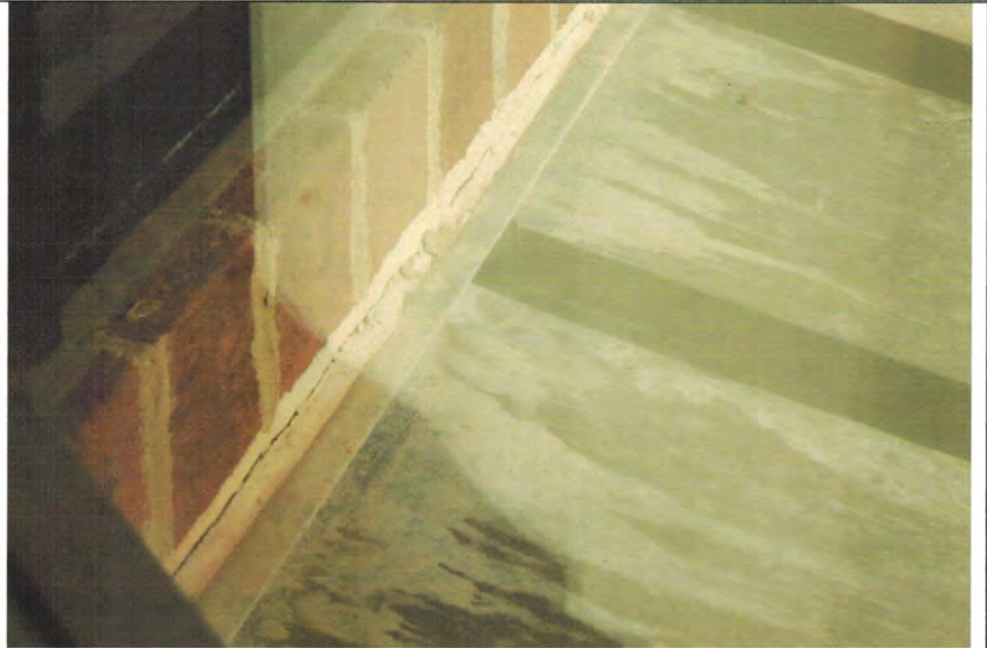
Photo Number: 21

View of caulk-covered flashing on mansard-style roof outside classroom 223 on building's south side. Notice how caulk is cracked.

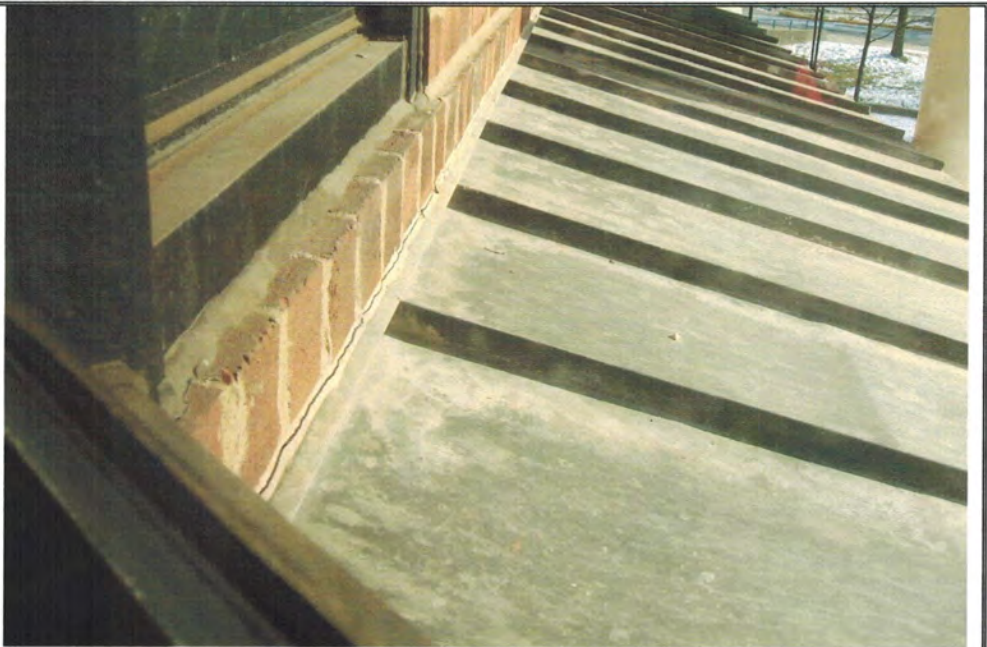
Photo Number: 22

View of caulk-covered flashing on mansard-style roof outside classroom 221 on building's south side. Notice how caulk is cracked.
